St. Bernard's Chapel

The votive chapel situated in Mulino street is dedicated to St. Bernard. It dates back approximately to the end of the 17th century or the early 18th century. It had been abandoned until 2014, when its painting and structure were restored. The restoration was conducted by the **Accademia di Belle Arti Aldo Galli**, an Academy of Fine Arts in Como, part of the IED Istituto Europeo di Design.

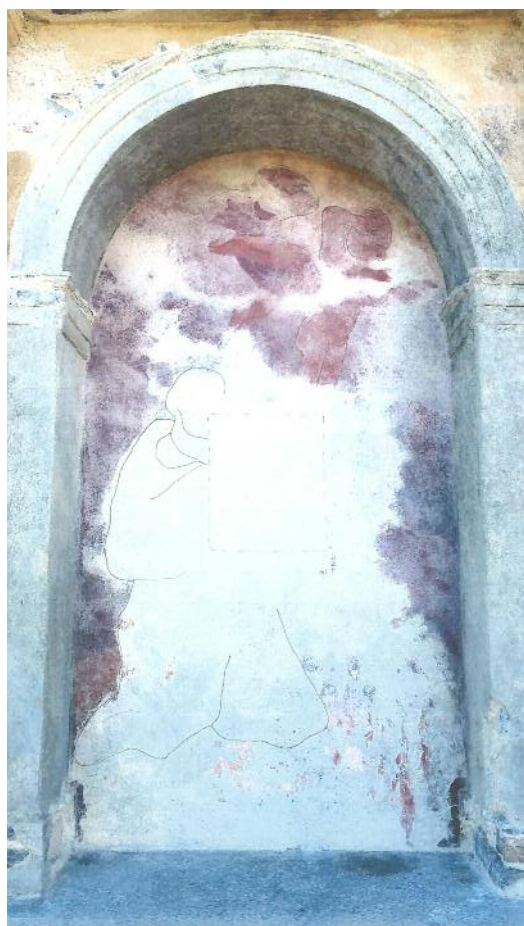
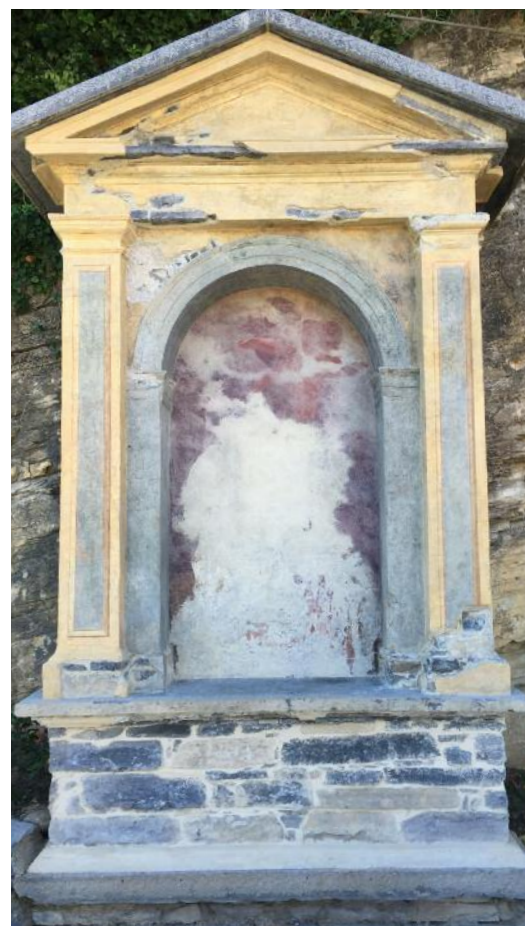
The structure presented problems of a static nature. Also, the plasters and the painted surface were extremely degraded and uneven. In fact, the weathering had caused loss and detachment of plaster and had washed the layers of paint.

Moreover, there were three maintenance pictorial stratifications in degraded conditions. It was possible to appreciate the original aspect due to an accurate stratigraphic investigation that took into account the well conserved few parts.

The raking light projected on the plaster revealed part of the trace of a carving representing the shape of St. Bernard. The traditional iconography of this Saint usually

The paint was fragmented; it was just possible to recognize a little angel's leg. Nowadays, it is possible to admire the complete figure of the angel in a horizontal position encircled with a drapery, thanks to the trimming and the pictorial retouching; moreover, it is possible to see the shape of another angel in a vertical position. Unfortunately, the draft of St. Bernard is not present anymore and it was not replaced in order to respect the originality of the artwork.
