St. Bernard's Chapel

The votive chapel situated in Mulino street is dedicated to St. Bernard. It dates back approximately to the end of the 17th century or the early 18th century. It had been abandoned until 2014, when its painting and structure were restored. The restoration was conducted by the **Accademia di Belle Arti Aldo Galli**, an Academy of Fine Arts in Como, part of the IED Istituto Europeo di Design.

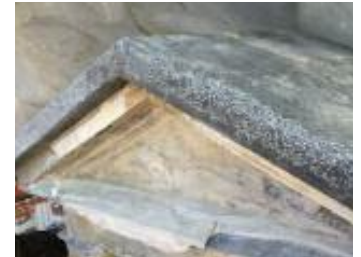
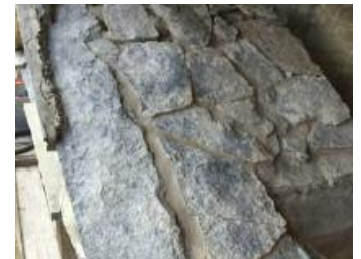
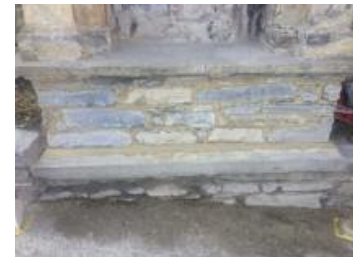
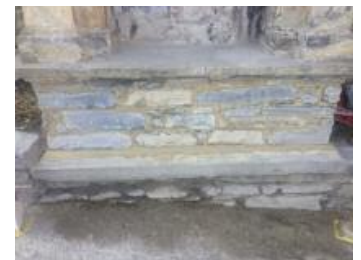
The structure presented problems of a static nature. Also, the plasters and the painted surface were extremely degraded and uneven. In fact, the weathering had caused loss and detachment of plaster and had washed the layers of paint.

Moreover, there were three maintenance pictorial stratifications in degraded conditions. It was possible to appreciate the original aspect due to an accurate stratigraphic investigation that took into account the well conserved few parts.

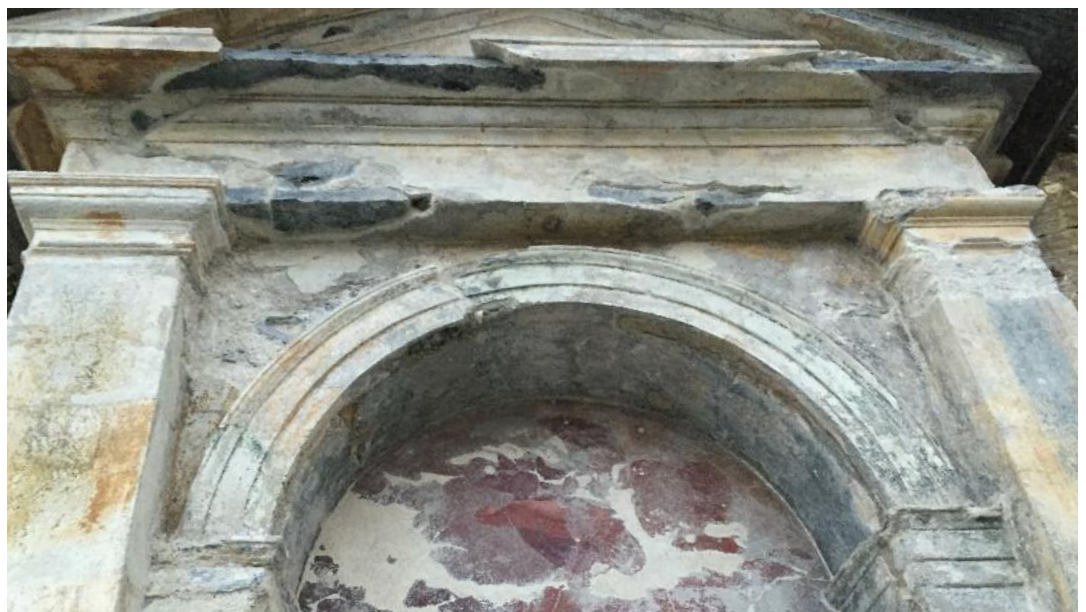
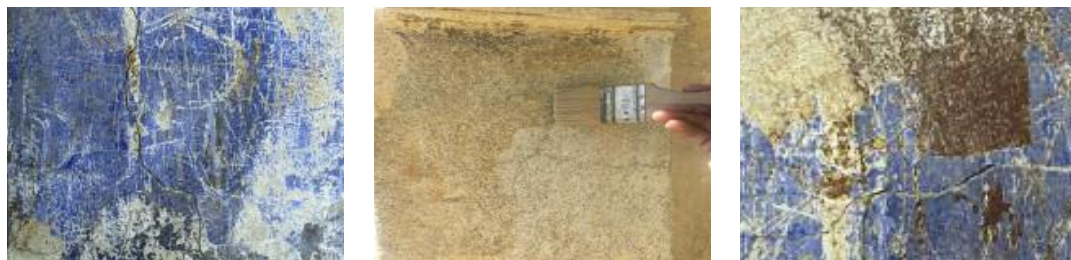
The raking light projected on the plaster revealed part of the trace of a carving representing the shape of St. Bernard. The traditional iconography of this Saint usually

depicts him seated in front of a desk, instead depictions of him on his knees praying, like this one, are less common.

The paint was fragmented; it was just possible to recognize a little angel's leg. Nowadays, it is possible to admire the complete figure of the angel in a horizontal position encircled with a drapery, thanks to the trimming and the pictorial retouching; moreover, it is possible to see the shape of another angel in a vertical position. Unfortunately, the draft of St. Bernard is not present anymore and it was not replaced in order to respect the originality of the artwork.
